## FRONT LOWER BALL JOINT ON-VEHICLE INSPECTION

SAORP-06

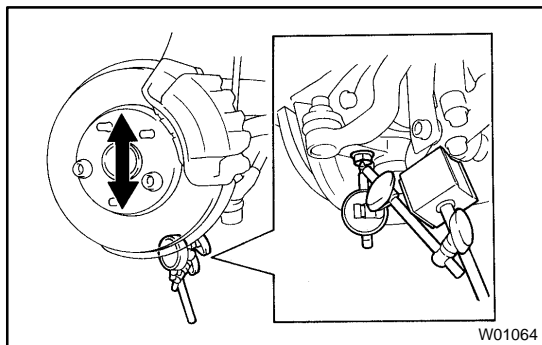
### INSPECT LOWER BALL JOINT EXCESSIVE PLAY ON-VEHICLE

- (a) Remove the front wheel and install the hub nuts to the disc.
- (b) Using a dial indicator, check the lower ball joint for excessive play when you push the hub nuts up and down with a force of 294 N (30 kgf, 66 lbf).

**Maximum: 0.9 mm (0.035 in.)**

If it is not within the specified value, replace the lower ball joint.
