DI2OX-03

DTC	Catalyst System Efficiency Below Threshold (Bank 1)

DTC	Catalyst System Efficiency Below Threshold (Bank 2)
	()

2000 LEXUS SC300/SC400 (RM715U)

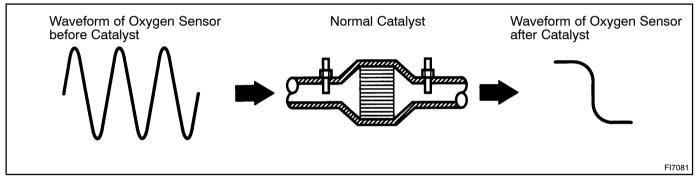
The ECM compares the waveform of the oxygen sensor located before the catalyst with the waveform of the oxygen sensor located after the catalyst to determine whether or not catalyst performance has deteriorated.

Air-fuel ratio feedback compensation keeps the waveform of the oxygen sensor before the catalyst repeatedly changing back and forth from rich to lean.

If the catalyst is functioning normally, the waveform of the oxygen sensor after the catalyst switches back and forth between rich and lean much more slowly than the waveform of the oxygen sensor before the catalyst.

But when both waveform change at a similar rate, it indicates that catalyst performance has deteriorated.

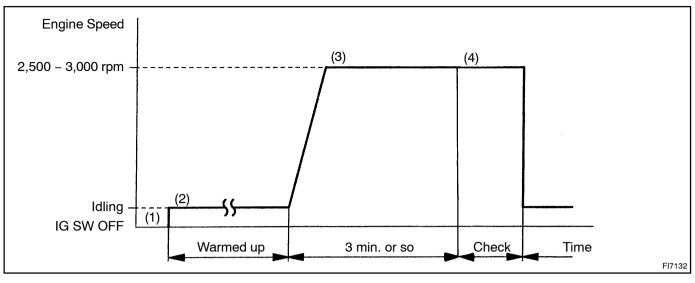
## **CONFIRMATION ENGINE RACING PATTERN**

- (1) Connect the LEXUS hand-held tester to the DLC3, or connect the probe of the oscilloscope between terminals OXL1, OXL2, OXR1, OXR2 and E1 of the ECM connectors.
- (2) Start the engine and warm it up with all the accessories switched OFF until engine coolant temperature is stable.
- (3) Race the engine at 2,500 3,000 rpm for about 3 min.
- (4) After confirming that the waveform of the heated oxygen sensor (bank 1, 2 sensor 1 (OXL1, OXR1)), oscillate around 0.5 V during feedback to the ECM, check the waveform of the heated oxygen sensor (bank 1, 2 sensor 2 (OXL2, OXR2)).

If there is a malfunction in the system, the waveform of the heated oxygen sensor (bank 1, 2 sensor 2 (OXL2, OXR2)) is almost the same as that of the heated oxygen sensor (bank 1, 2 sensor 1 (OXL1, OXR1)) on the left.
