INSPECTION

2005 LEXUS IS300 (RM1140U)

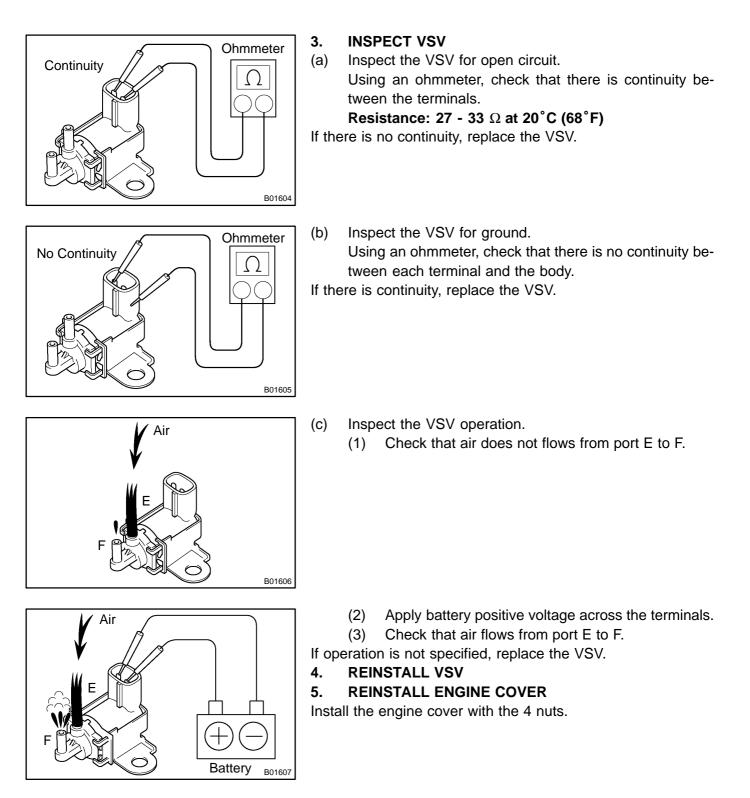
2. REMOVE VSV
